Here's the regulator, you can see the remains of the broken clips:

Thanks to Fab ([ftillier](#)) for the Photo's & Guide

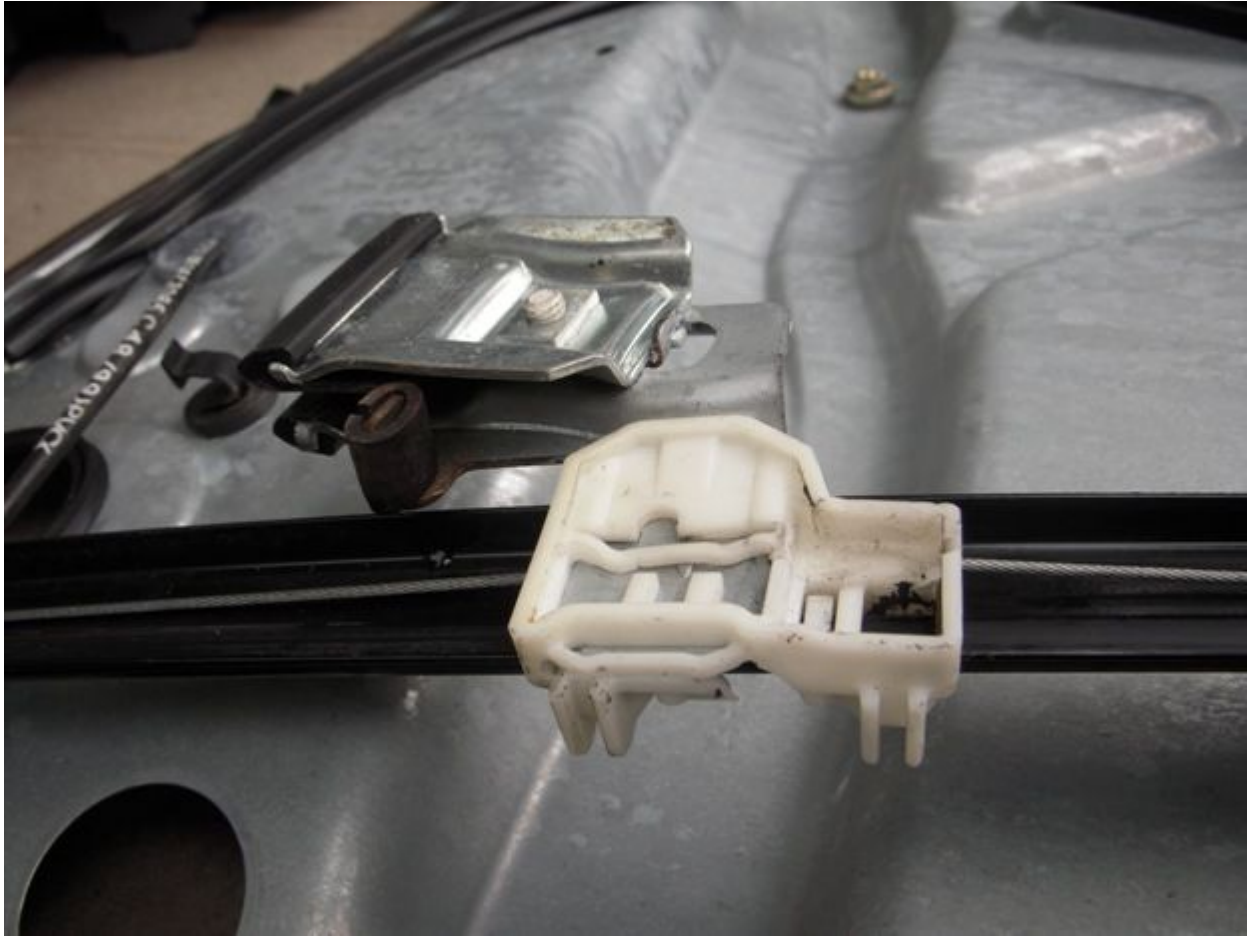
Here's the rear clip pieced back together as best I could:

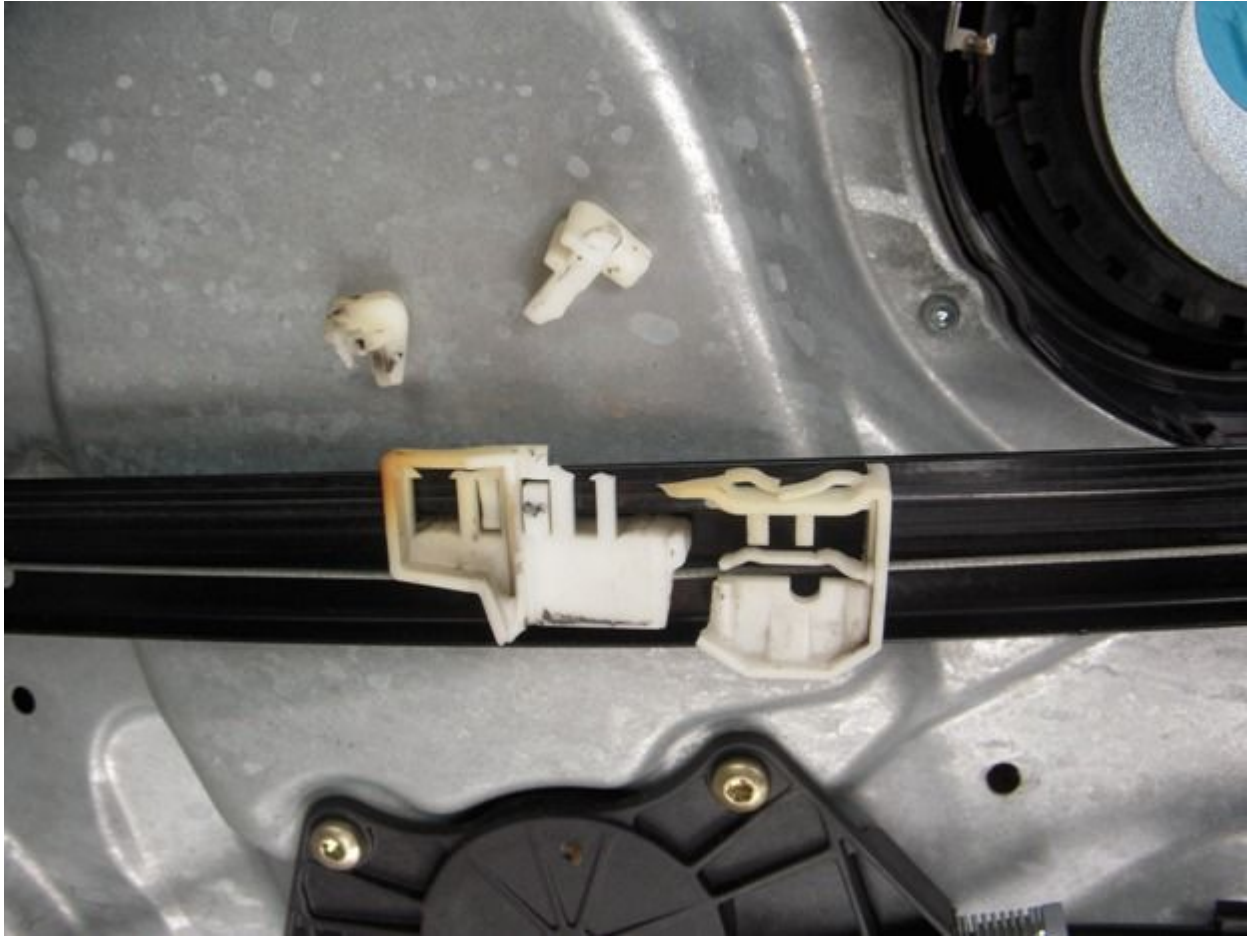
Front clip, in pieces:

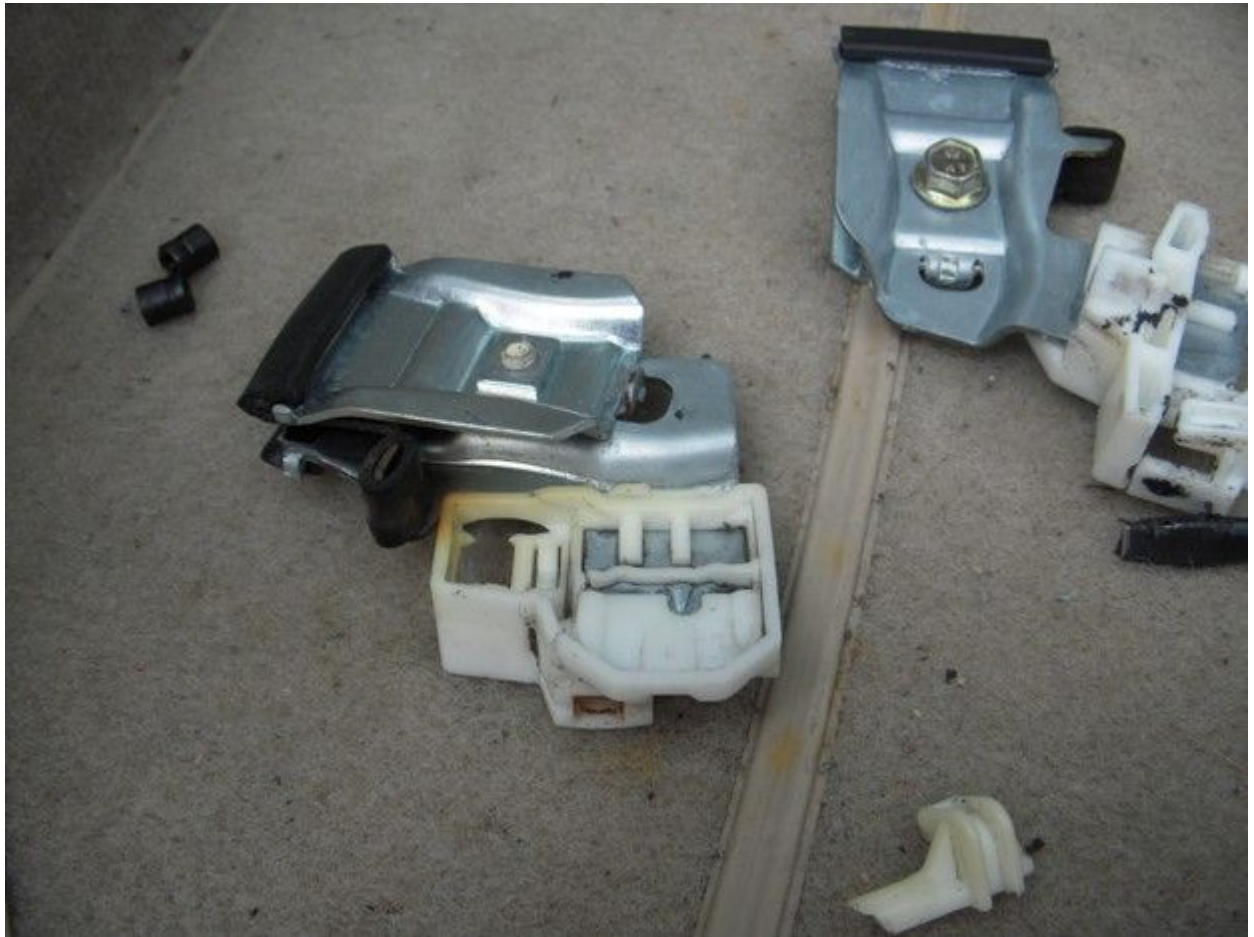
Here's what the front clip should look like when on the arm:

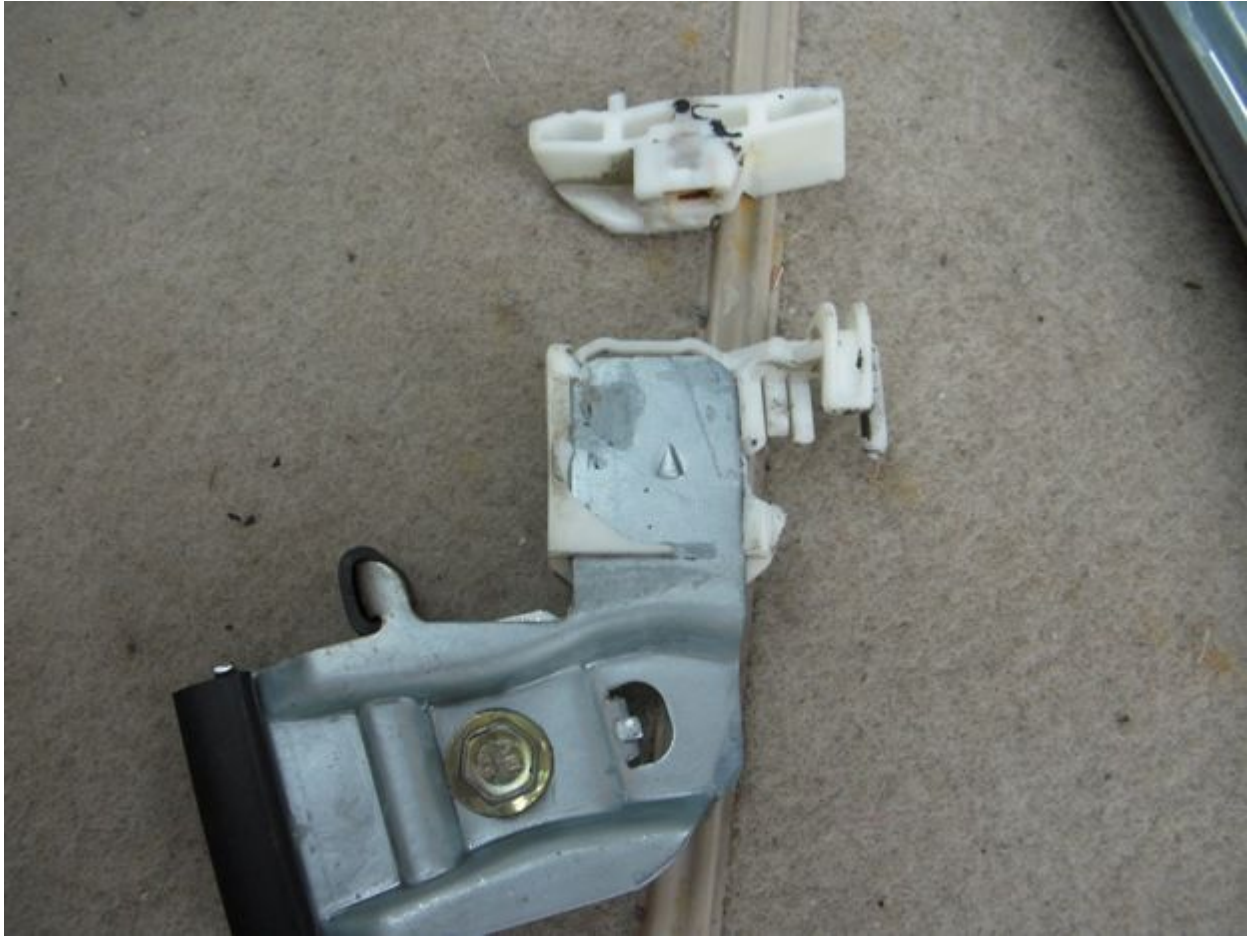
Rear clip, on arm but exploded, shows position of arm with respect to clip (look for triangular indent):

I used the triangular bump as a guide, using the lower corner as best I could as a starting point.

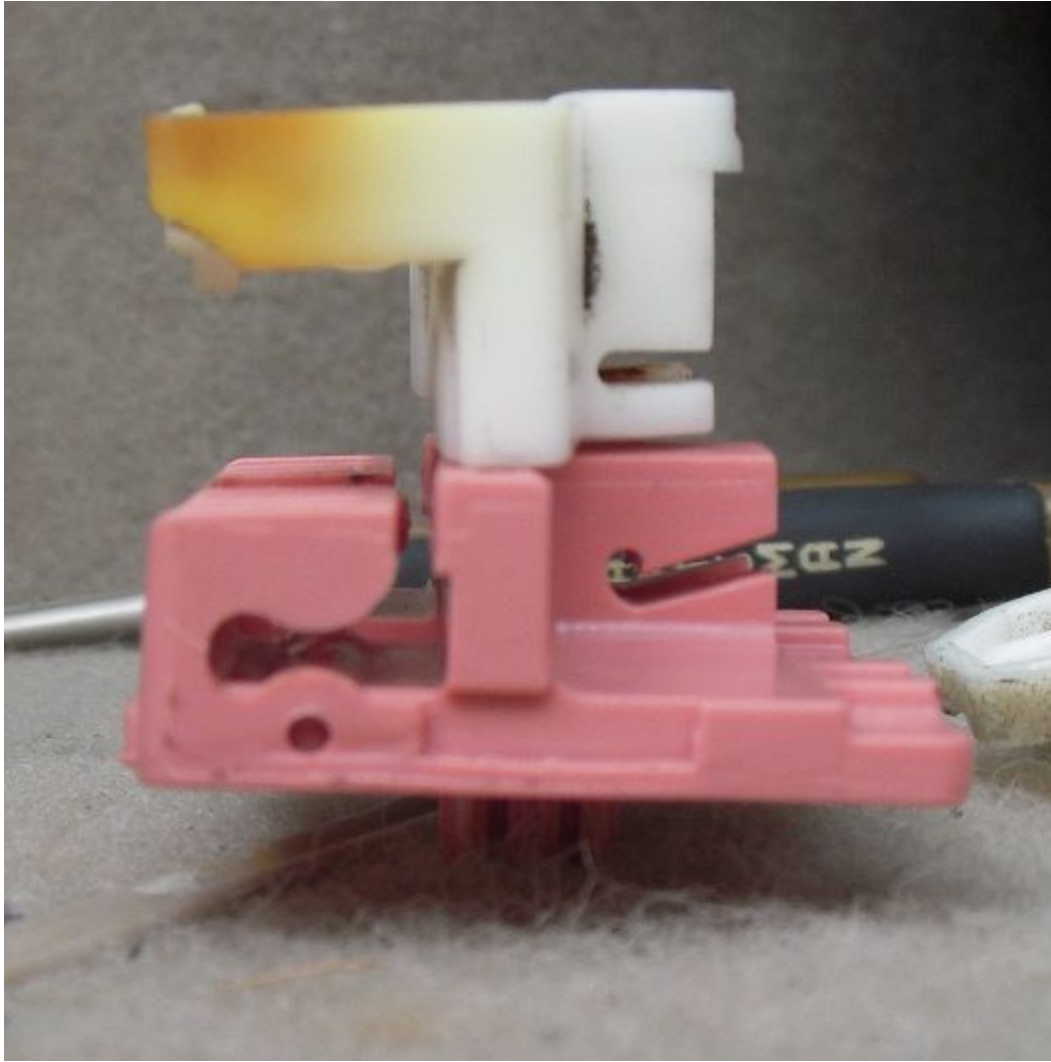
Here's the Audi pink clip and the original, end view, showing the cable position:

Another thing to note, but I didn't get a picture of it, is the opening for the cable nub in the pink brackets is wider than in the original. This means there can be a little more play in the window. I didn't notice any issue related to this, however. The window goes up and down just fine, no binding or anything.

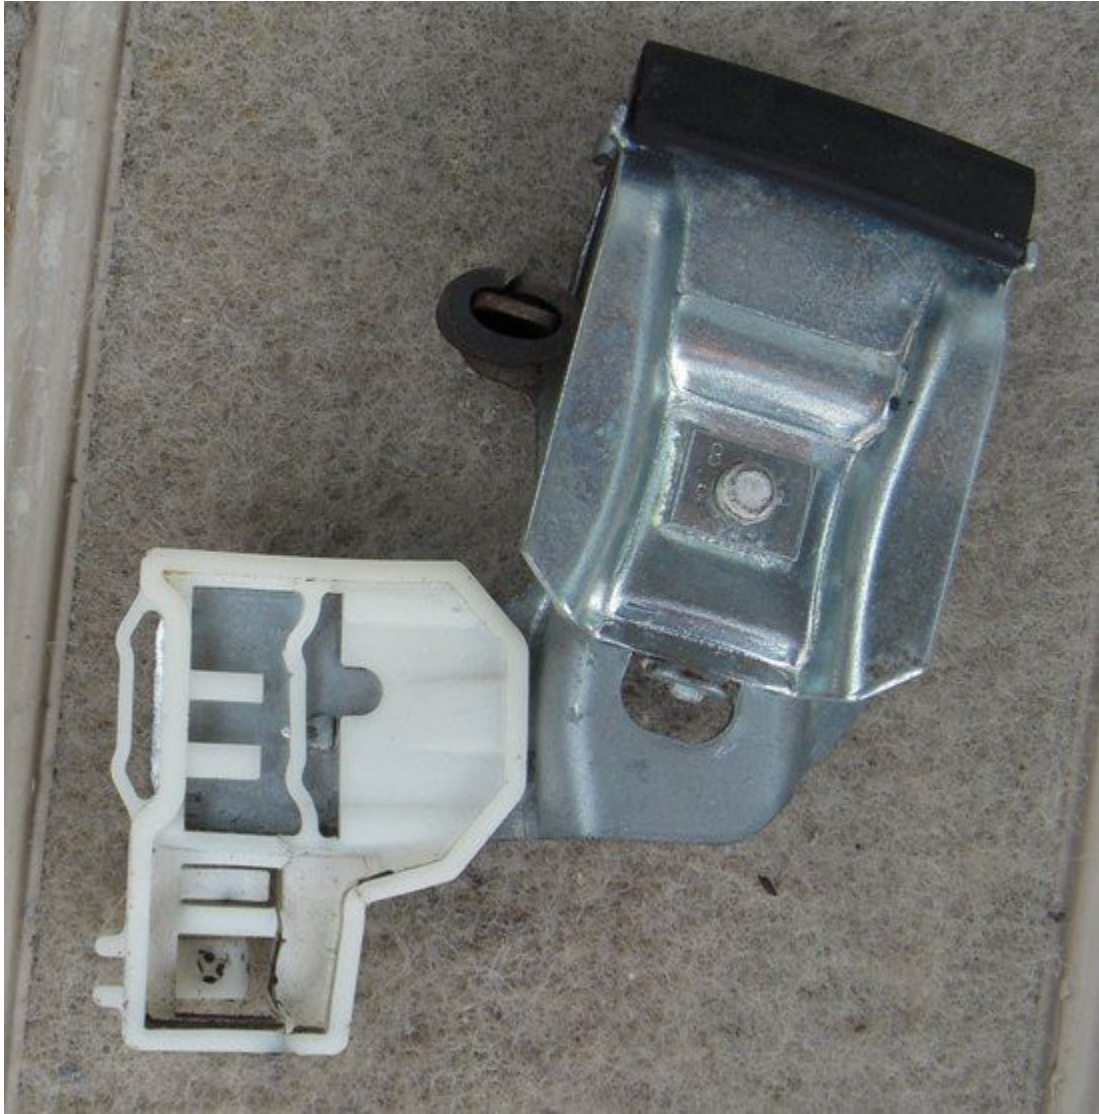
Now with the bracket:

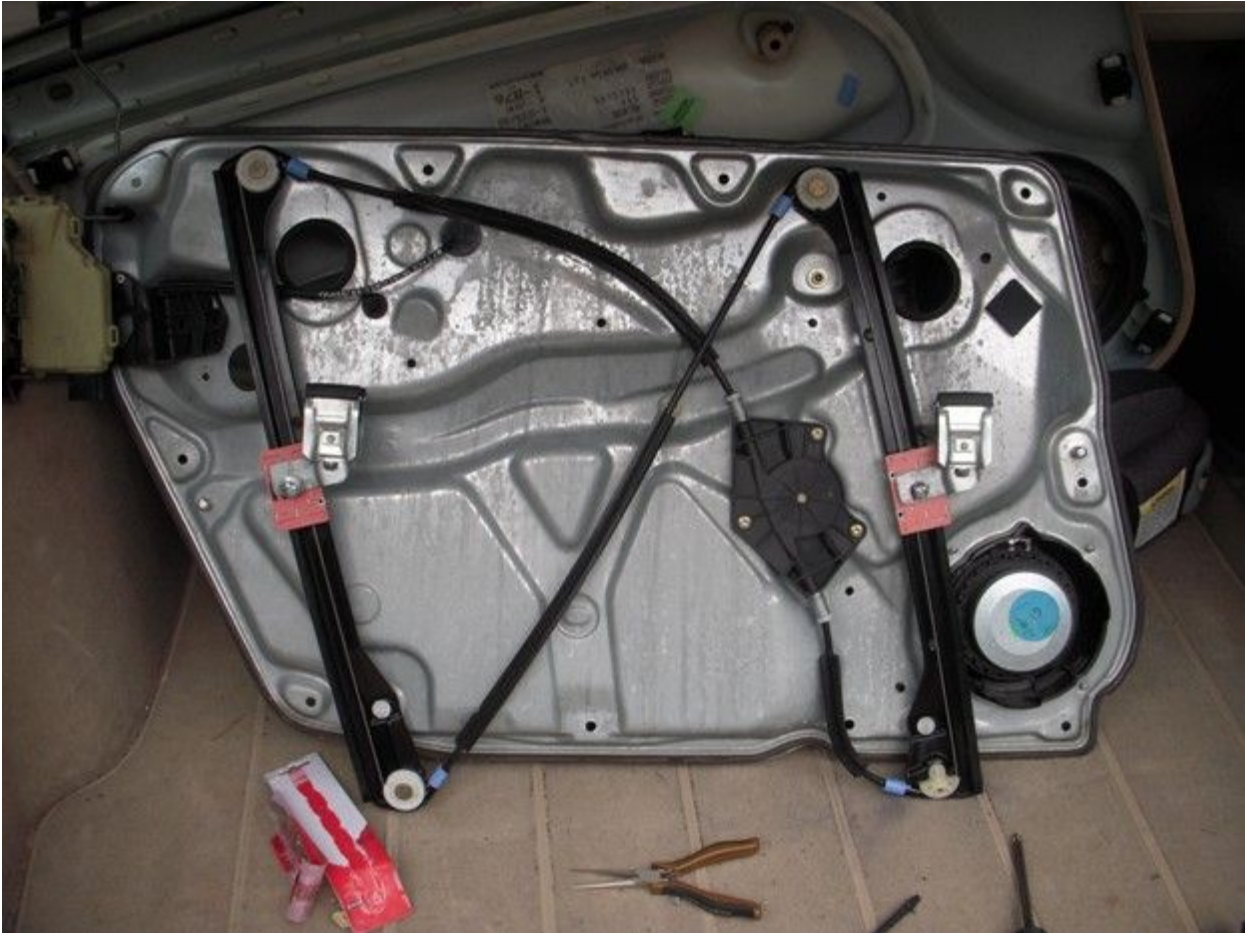
Put it all back together:

And then reinstalled everything into the door.

Final thoughts: The position of the brackets is about 1/8 to 3/16" too low, but you can make up for that by shifting the glass up when you clamp it. If it was the other way, it wouldn't work and cause the window to bind when you put it up. But the way the first bracket got mangled had me seriously doubting whether it would work again, and make my attempts at a cheap and quick fix neither. It ended up taking quite a bit of extra time. **Correction: Looking at the pictures I just realized that the cable nub aligns with different edges for the front and rear brackets. So trying to offset the hole down as much as possible is "correct" for the rear bracket, but not the front, unless I'm just confusing myself further... So it looks like my front bracket is too tall by a good amount. Note that I can't fix this with the carnage I've made of that bracket.**

I used a #12 1/2" long screw in the clip's post, which worked like a charm.
