# Focus on... brake discs.

# About the tests

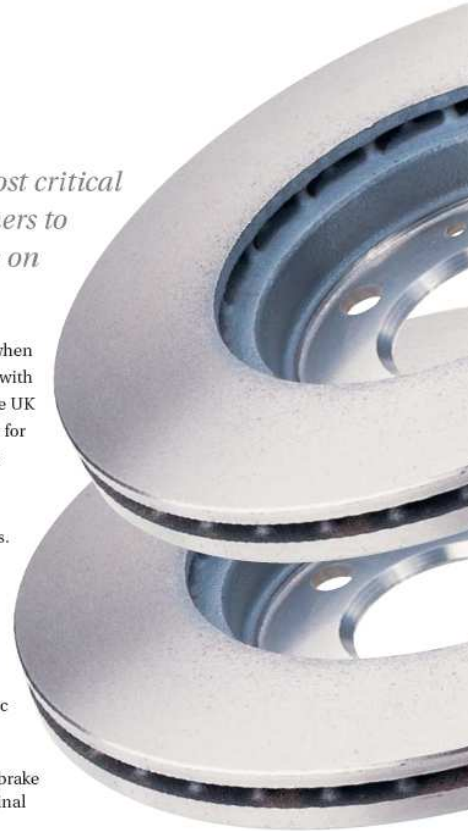
Figure 1. The 'other brand' brake disc in the second series of tests after 438 braking cycles. The disc has completely cracked.

Comparison of average figures from 364 braking cycles with the 'other brand' brake disc and 792 braking cycles with the Volkswagen original brake disc showed:

- The service life of the Volkswagen original brake disc is more than twice that of its non-original counterpart.
- Serious cracking in the non-original disc.

**In every series of tests, the 'other brand' brake discs cracked much earlier than the Volkswagen original brake discs. Overall, the Volkswagen disc proved to have more than twice the service life of its non-original counterpart.**

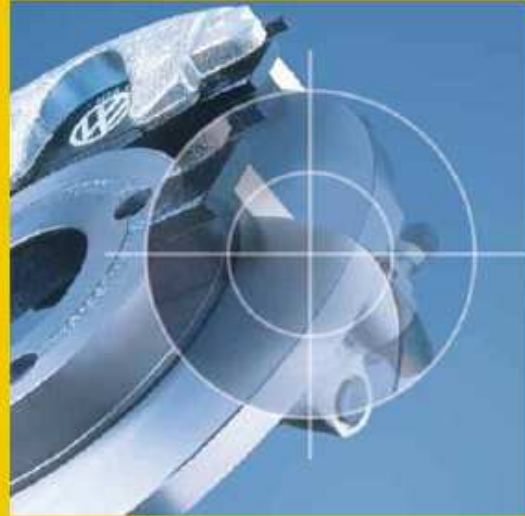
Figures 2 and 3. A Volkswagen original brake disc in the last series of tests after 440 braking cycles. Only light cracking is evident.
